LIGONIER DAM

NDI No. PA 00477
PennDER No. 65-117

PHASE I INSPECTION REPORT
NATIONAL DAM INSPECTION PROGRAM

March 1980

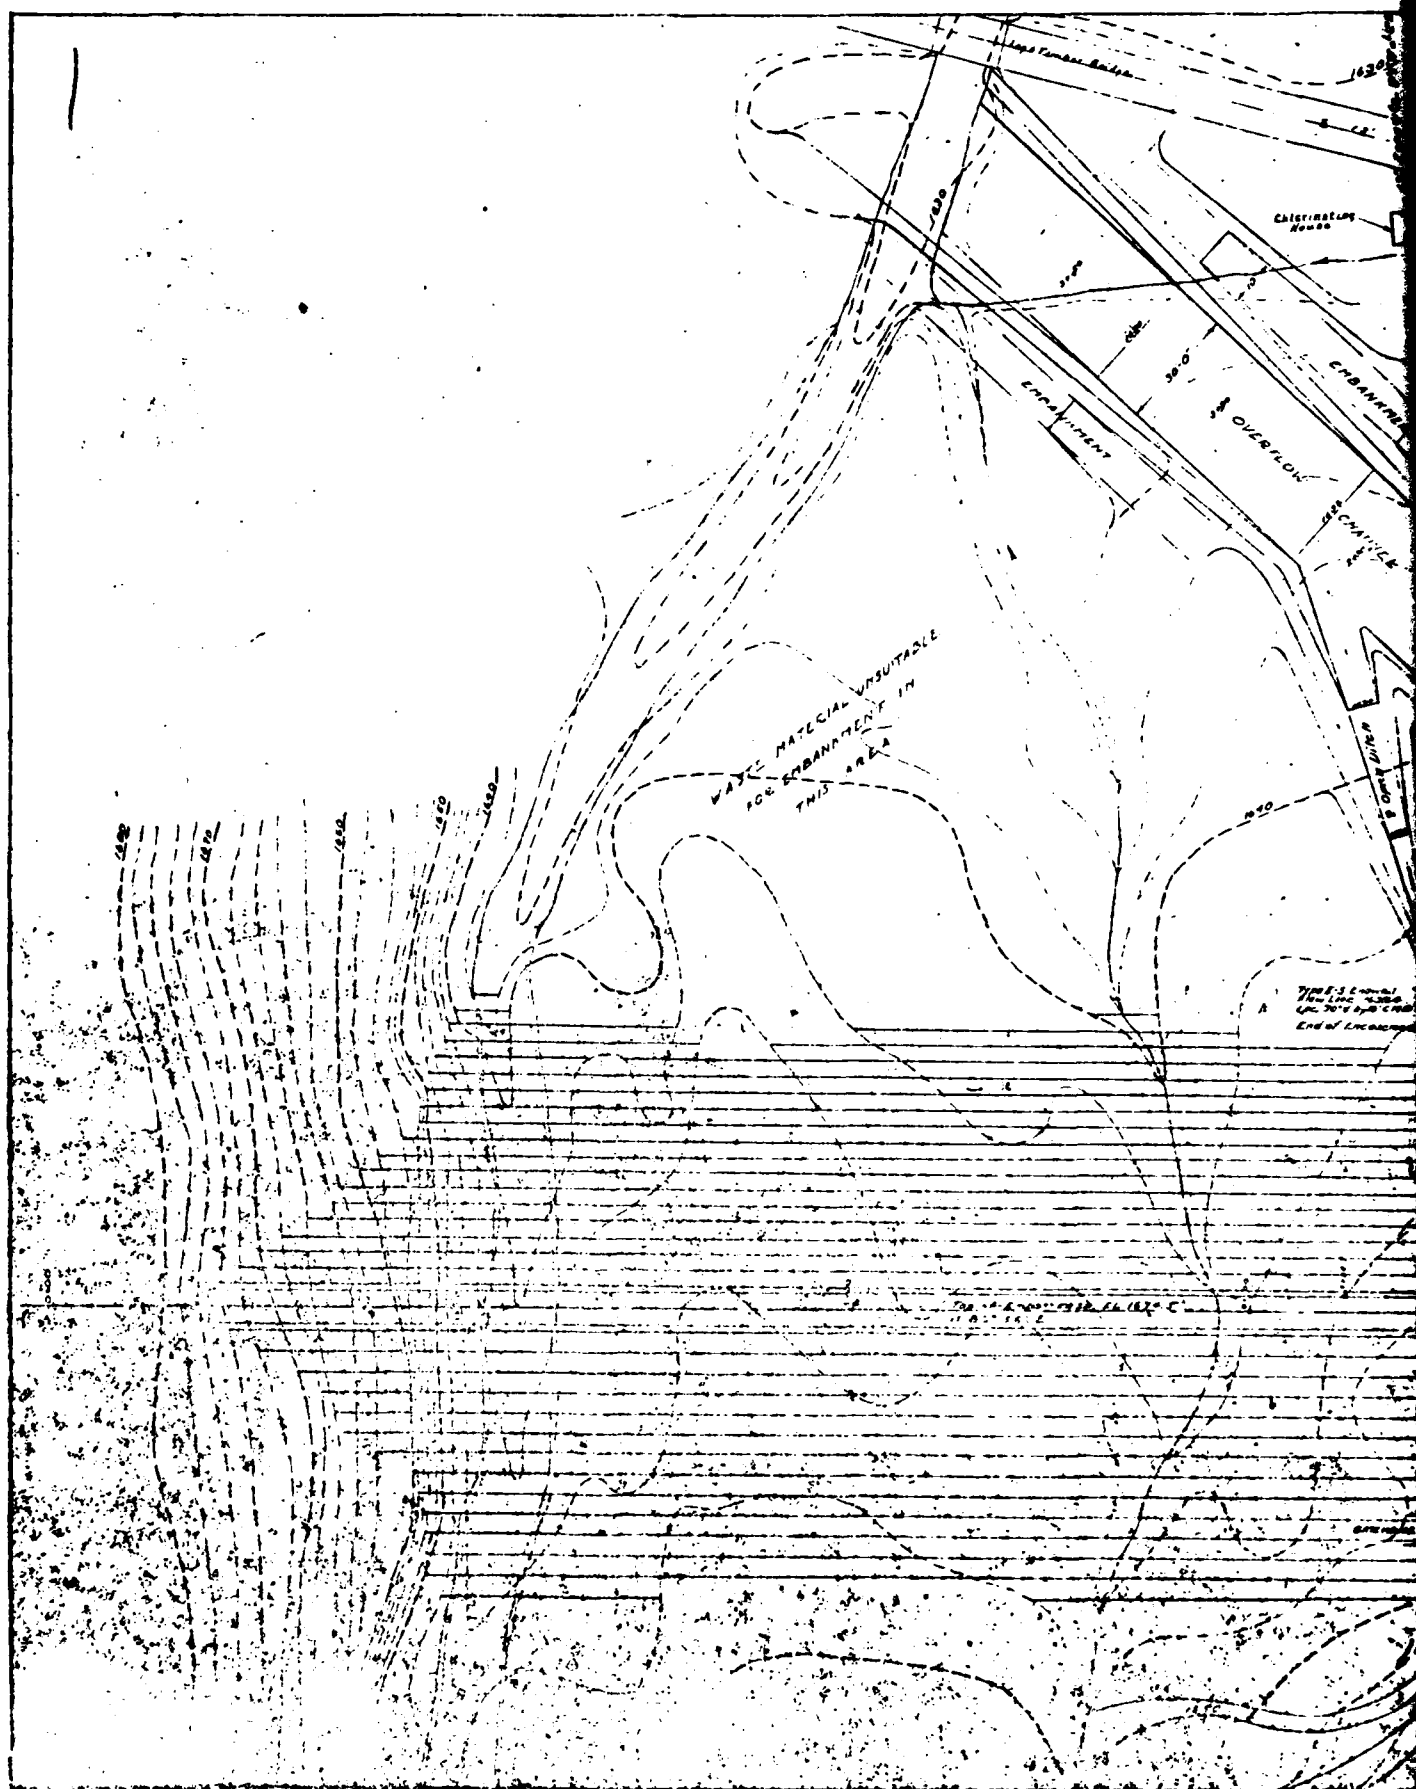
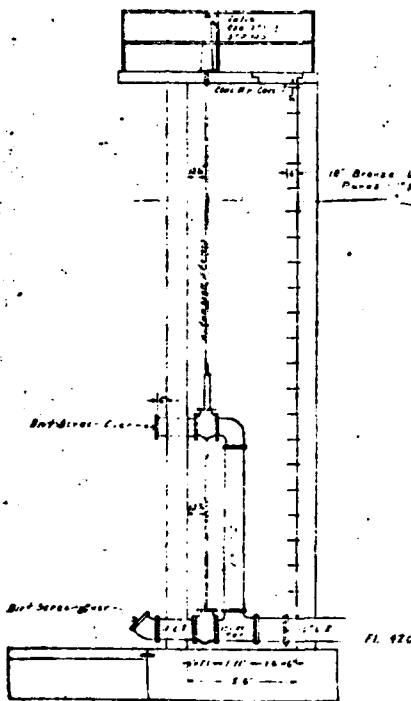
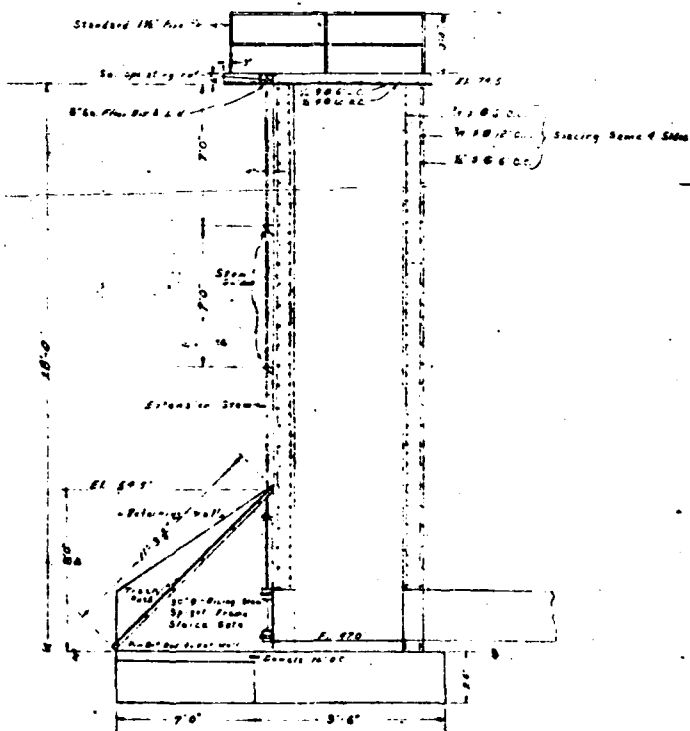
PLATE 5

- DETAILS	See Plate 5 of this report.
- CONSTRAINTS	The original 30 in. sluice gate has been replaced by a steel plate used for shoring in the intake tower and a smaller diameter (estimated 12 in.) pipe which discharges into the 30 in. C.M.P.

recommendations for remedial work, as necessary, and develop recommendations for the repair of the corroded section of pipe and the void under the pipe.

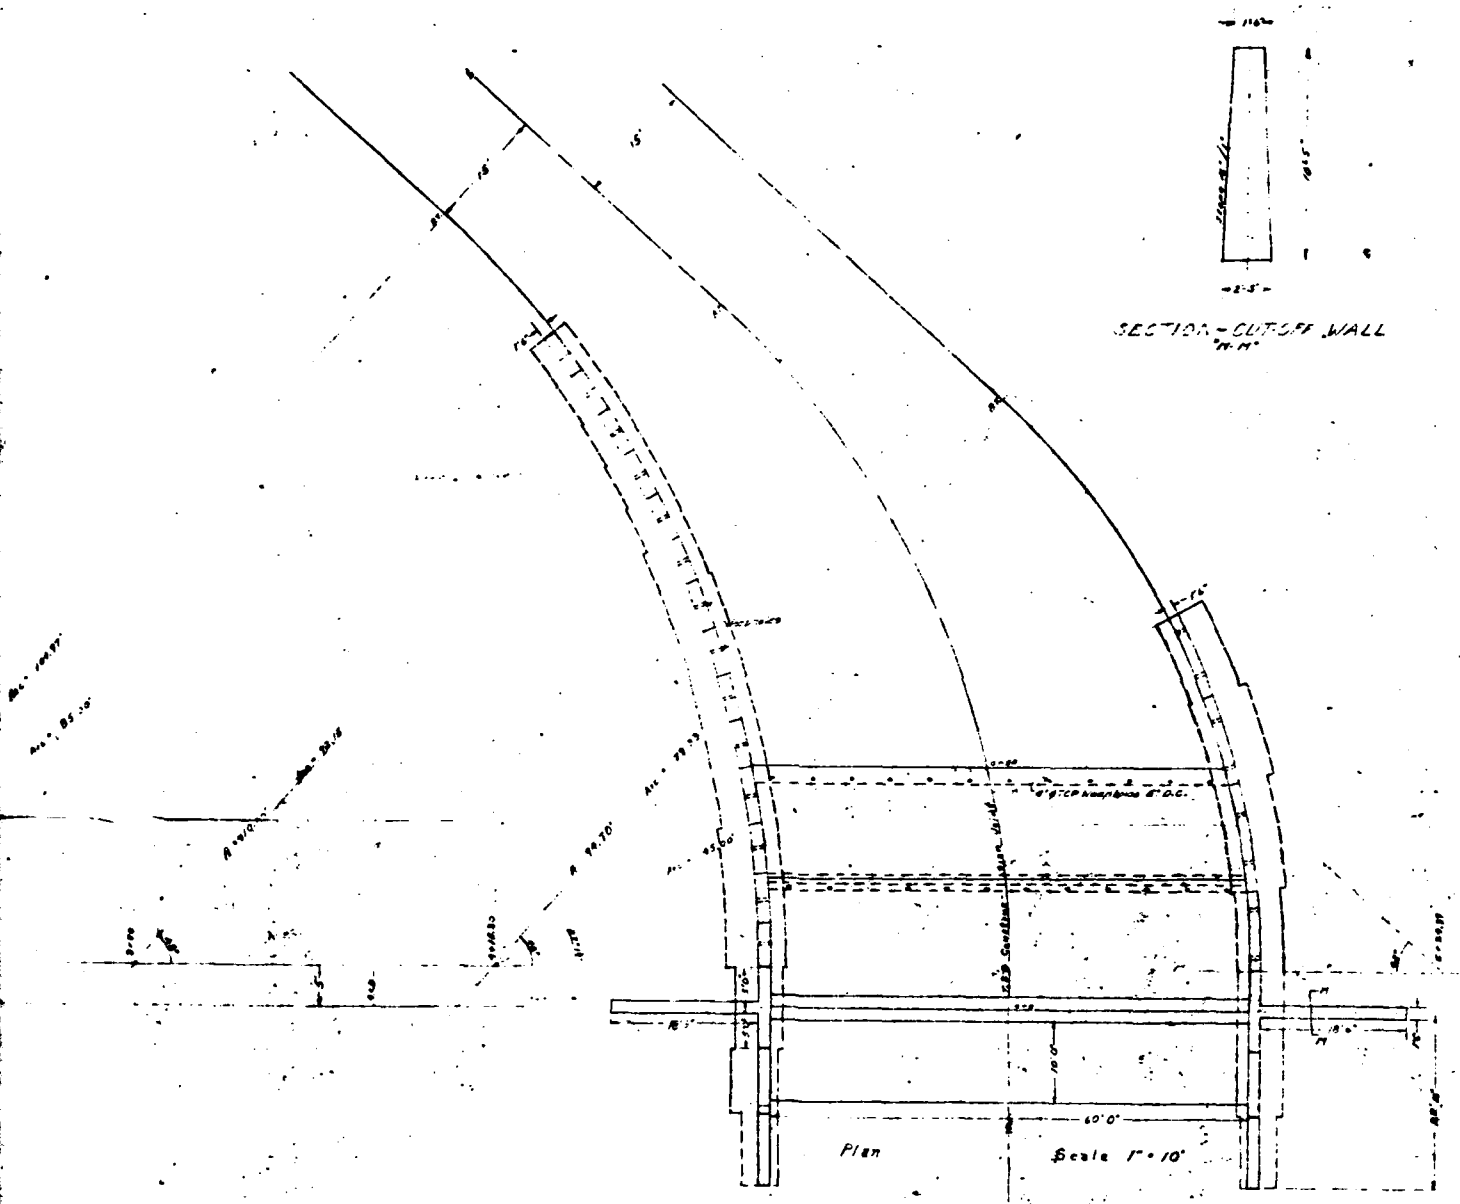
SPILLWAY DETAILS

No deficiencies or items of repair work were observed for the spillway structure. This structure appeared to be in good condition.
